Fractures Mechanics

L. Barrallier¹

23 mars 2010

The material and the design of RMS Titanic

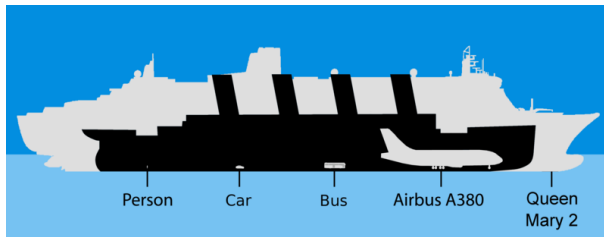
- ▶ Length 269 m
- ▶ Width 30 m
- ▶ Draft (from waterline to bottom of the hull) ≈ 11 m
- ▶ Depth (from waterline to deck) 45.5 m
- ▶ Weight 52250 t
- ▶ Power 33.1 MW
- ▶ Speed 42-45 km.h⁻¹

Comparison of Titanic size with Queen Mary II and Airbus A380

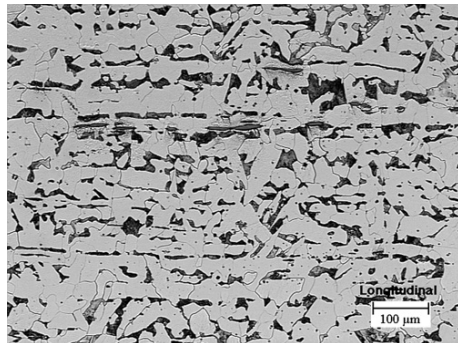
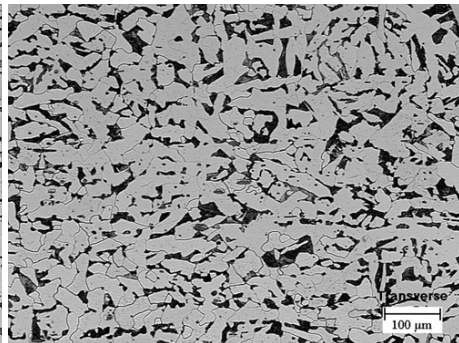
Hull steel microstructure

Longitudinal direction (average grain diameter $\approx 60 \mu\text{m}$) – Transversal direction (average grain diameter $\approx 42 \mu\text{m}$)

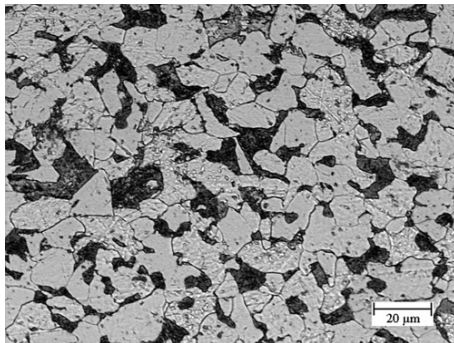
Modern A36 microstructure

Longitudinal direction (average grain diameter $\approx 26 \mu\text{m}$)

- Hall-Petch equation : $\sigma_{ys} = a + b d^{-1/2}$
- Yield strength of steel with 26 μm grain size is about 27 % higher than that of a steel with 42 μm grain size if the value of a is small

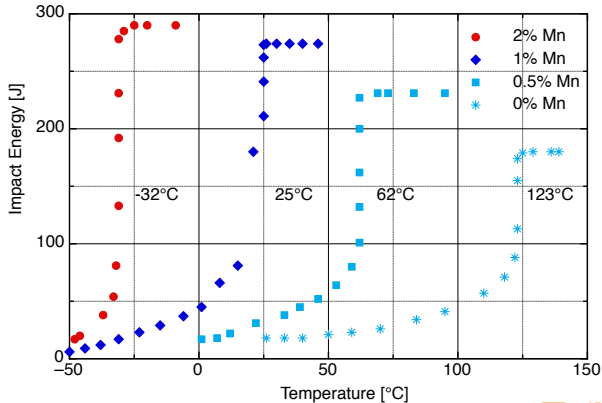
- Higher %Mn is beneficial to prevent ductile to brittle transition because Mn prevents formation of brittle iron sulfides

Effect of Mn composition on ductile/brittle temperature

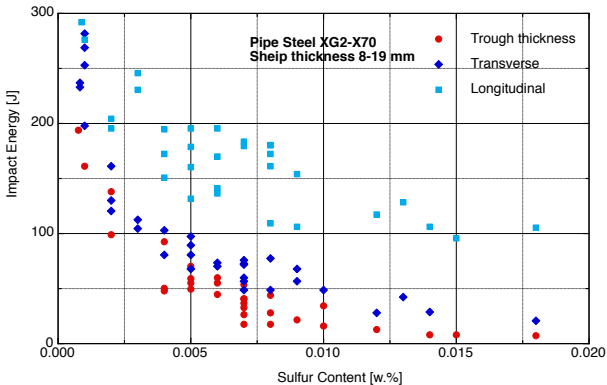
- Lower %S is beneficial to prevent ductile to brittle transition because S prevents formation of brittle iron sulfides

Effect of S composition on ductile/brittle temperature

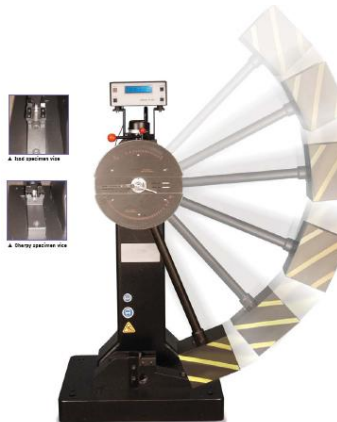
- ▶ The energy absorption is a measure of the impact energy
- ▶ The results are qualitative in nature and are useful in making comparisons
- ▶ Determine whether or not a material experiences a ductile/brittle transition with decreasing temperature and, if so, the range of temperatures over which it occurs

Charpy Tester and Sample

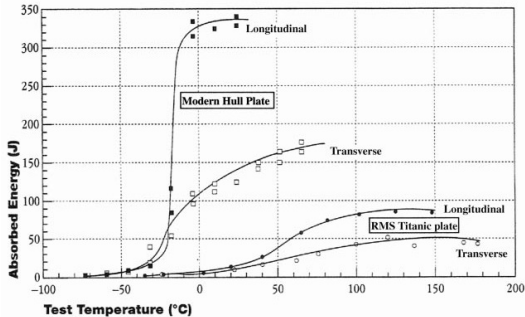
Effect on Temperature on Modern and Titanic Steel

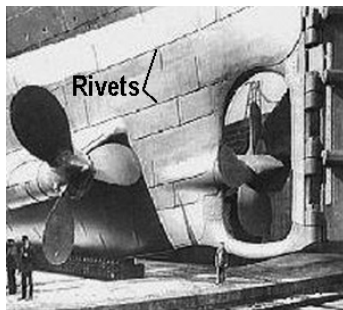
- ▶ Tremendous forces were created on impact with the iceberg
- ▶ Rivets failed either in shear or by elongation
- ▶ Rivet heads in the areas of contact were simply popped off
- ▶ More seams opened up.
- ▶ Water was flooded the hull of the ship

Rivets were made from wrought iron – Rivets repartition

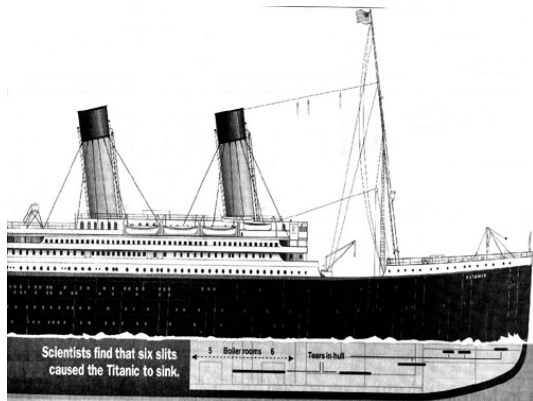
- ▶ Along with the material failures, poor design of the watertight compartments in the Titanic's lower section was a factor in the disaster.
- ▶ The transverse bulkheads of the watertight compartments should have been raised.

Layout of watertight compartments
