Introduction to Carburizing and Carbonitriding

Possible Complications

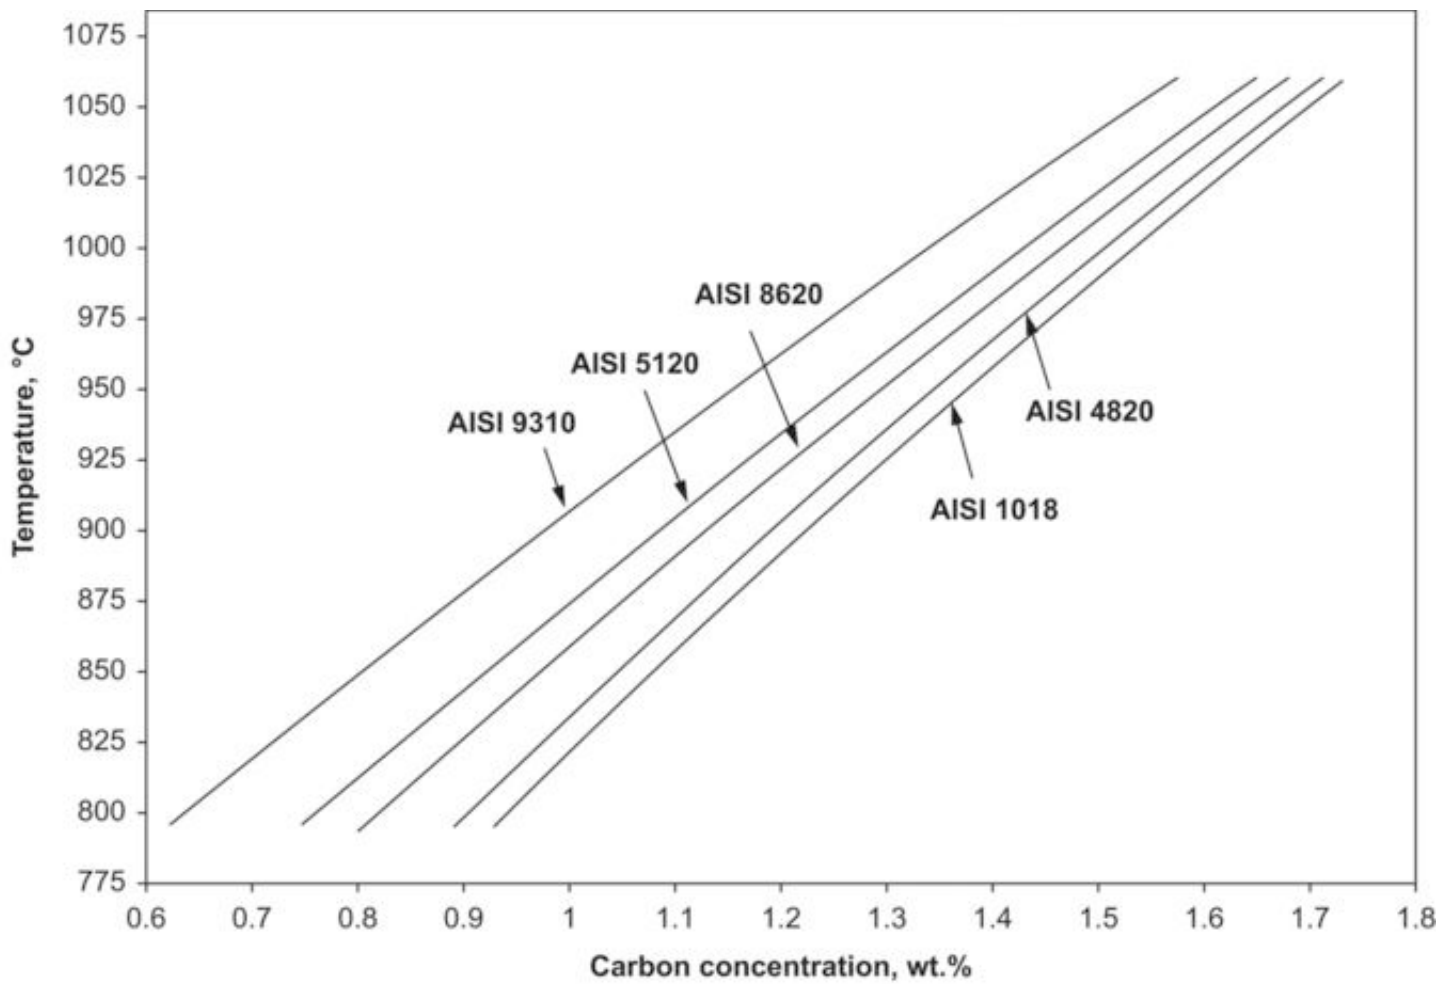
Compositions used in calculations of saturation limits						
	1018	4118	4820	5120	8620	9310
C	0.18	0.2	0.2	0.2	0.2	0.1
Mn	0.75	0.8	0.6	0.8	0.8	0.55
Cr		0.5	—	0.8	0.5	1.2
Ni			3.5		0.55	3.25
Mo			0.25		0.2	0.1

Fig. 21 Carbon saturation limit in austenite for common AISI steel grades, calculated using Thermo-Calc. Source: [Ref 6](#)

- *Excessive carbon content:* If the surface carbon of the carburizing medium is higher than the saturation carbon level of the steel ([Fig. 21](#)), it will begin to form iron carbide. There is no known benefit to carburizing at carbon levels higher than saturation. It is generally considered good practice to carburize at a carbon concentration just below the saturation carbon level, to maximize the increased diffusion rate achieved at higher carbon levels. The appropriate carbon potential can be easily controlled through the use of modern atmosphere-monitoring equipment and instrumentation. Maximum solubility limits of carbon in austenite are listed in [Table 4](#) at typical carburizing and quench temperatures for some common carburizing steels.

Steel	Maximum solubility of carbon (wt%) in austenite (from Fig. 21) at:		
	925 °C (1700 °F)	845 °C (1550 °F)	800 °C (1475 °F) ^(a)
1018	1.3	1.07	...
4820	1.27	1.03	...
5120	1.17	0.91	...
8620	1.21	0.96	...

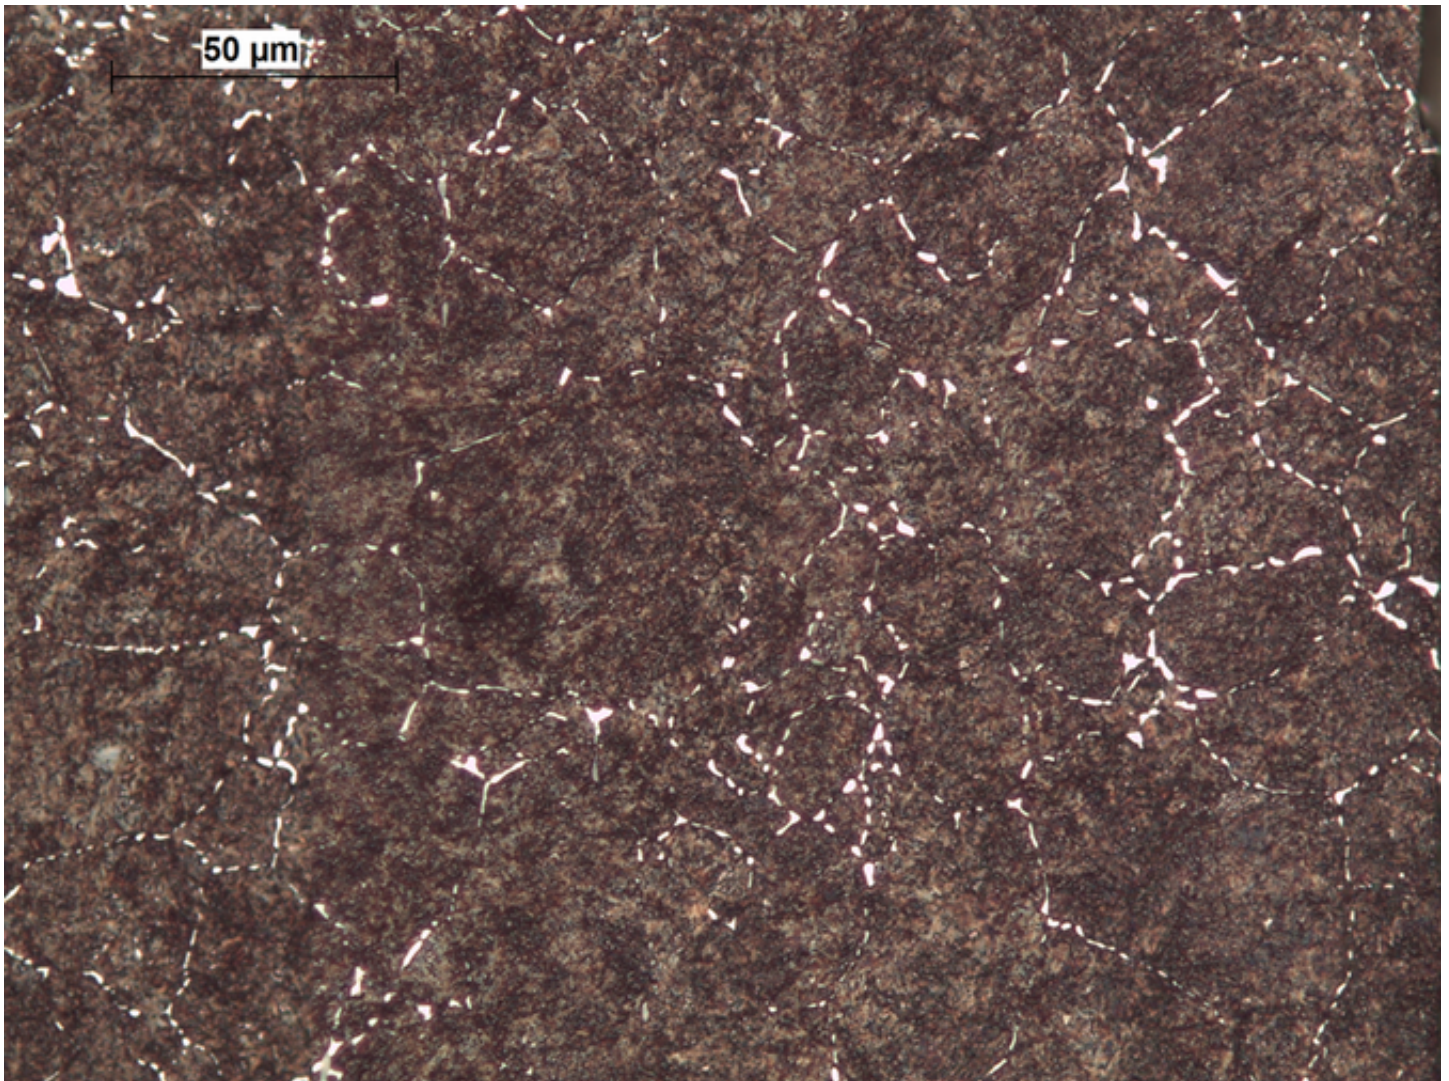
Fig. 22 Network carbides in a carburized case. Note how carbides outline the prior-austenite grain boundaries. 8620-grade steel. Nital etch. Original magnification: 500×

Carbides present in an etched microstructure as distinct, light-colored, round-cornered features that can be present in a variety of morphologies ranging from discrete, individual carbides to a network around the prior-austenite grain boundaries (Fig. 22), also known as a continuous carbide network.

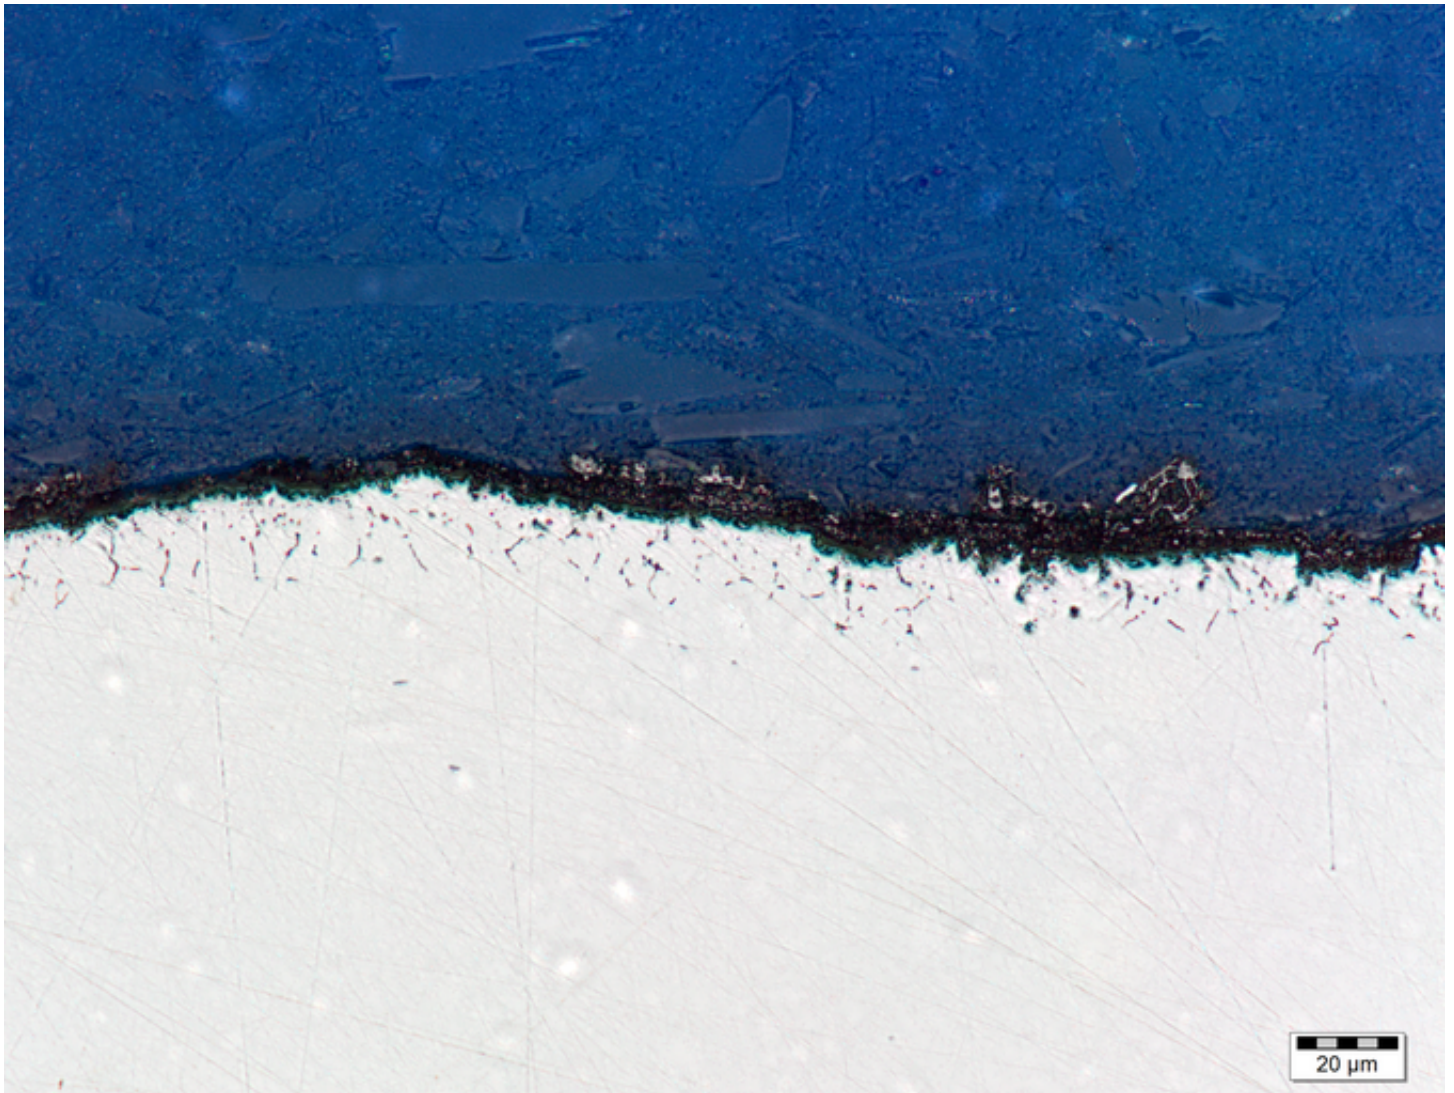
Fig. 23 Intergranular oxidation at the surface of a carburized component. Unetched. Original magnification: 500×

Intergranular oxidation ([Fig. 23](#)) is unavoidable in gas-carburized steels, but it is predictable. In a normally operating furnace, intergranular oxidation typically develops at a rate of 0.0025 mm (0.0001 in.) per 0.25 mm (0.010 in.) of case depth, maxing out at a depth of approximately 0.013 mm (0.0005 in.). Intergranular oxidation penetration much greater than 0.013 mm (0.0005 in.) usually indicates that there is a significant atmosphere leak in the furnace.
